== USS VICKSBURG (CG-69) ==
SEMAT II SHELL CONDITION ASSESSMENT
SURVEY
INTERIOR AREAS
10/22/01 TO 11/02/01

PREPARED BY
SUPERVISOR OF SHIPBUILDING CONVERSION
AND
REPAIR
PORTSMOUTH, VIRGINIA
11/09/01

USS VICKSBURG (CG-69)
SHELL CONDITION ASSESSMENT SURVEY, INTERIOR AREAS.

A SEMAT II UNDERWATER HULL AND SUPPORTING STRUCTURE SURVEY OF INTERIOR AREAS WAS CONDUCTED ON BOARD **USS VICKSBURG (CG-69)** FROM 10/22/01 TO 11/02/01 AT MAYPORT NAVAL STATION, JACKSONVILLE FLORIDA.

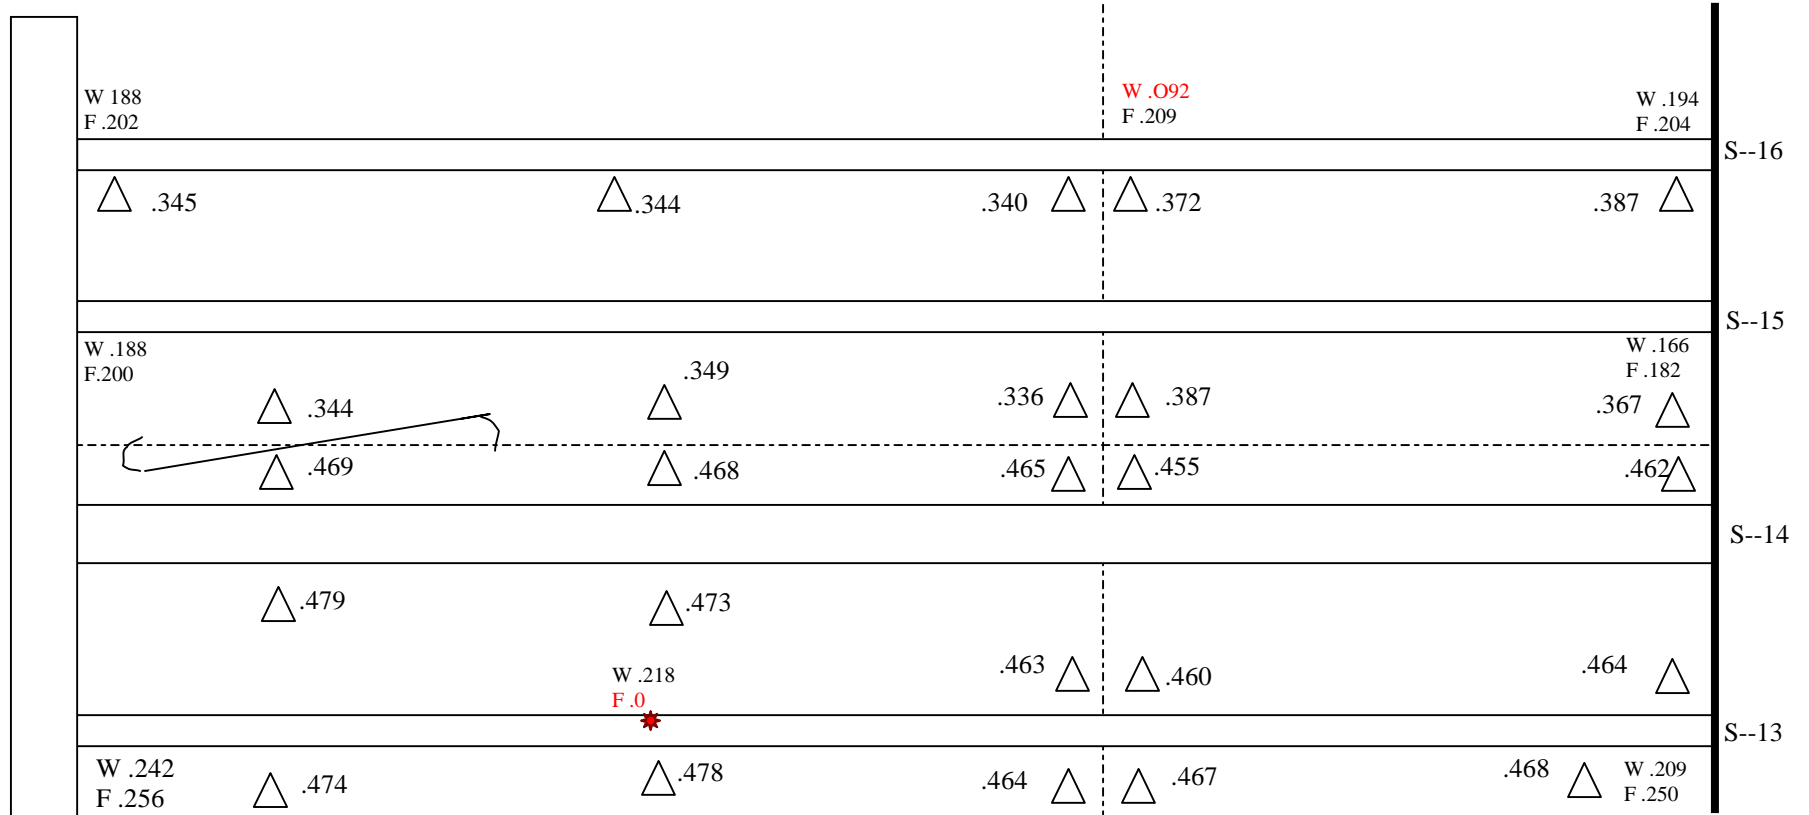
BHD 300

CORROSION AT TRANSVERSE WELD SEAM UNDERNEATH 3RD STRINGER FROM
MARGIN PLATE

TRANSVERSE WELD SEAM

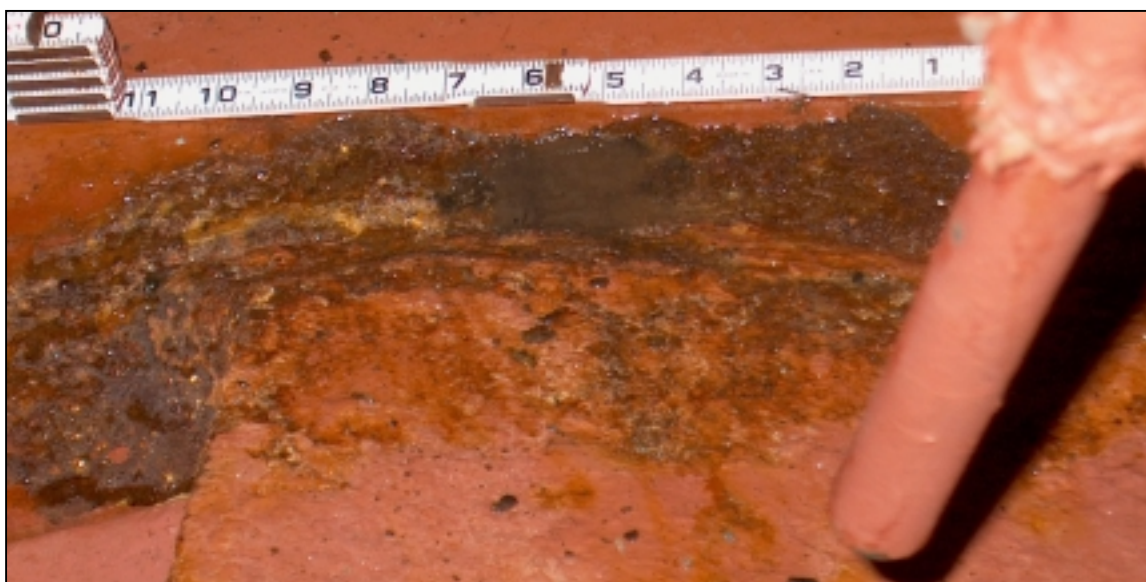
STBD SIDE, CORROSION ON TANK TOP AND STIFFNER UNDERNEATH
FIRE PUMP NO.4. ARROW INDICATES DRAIN LINE, ROOT CAUSE OF CORROSION.

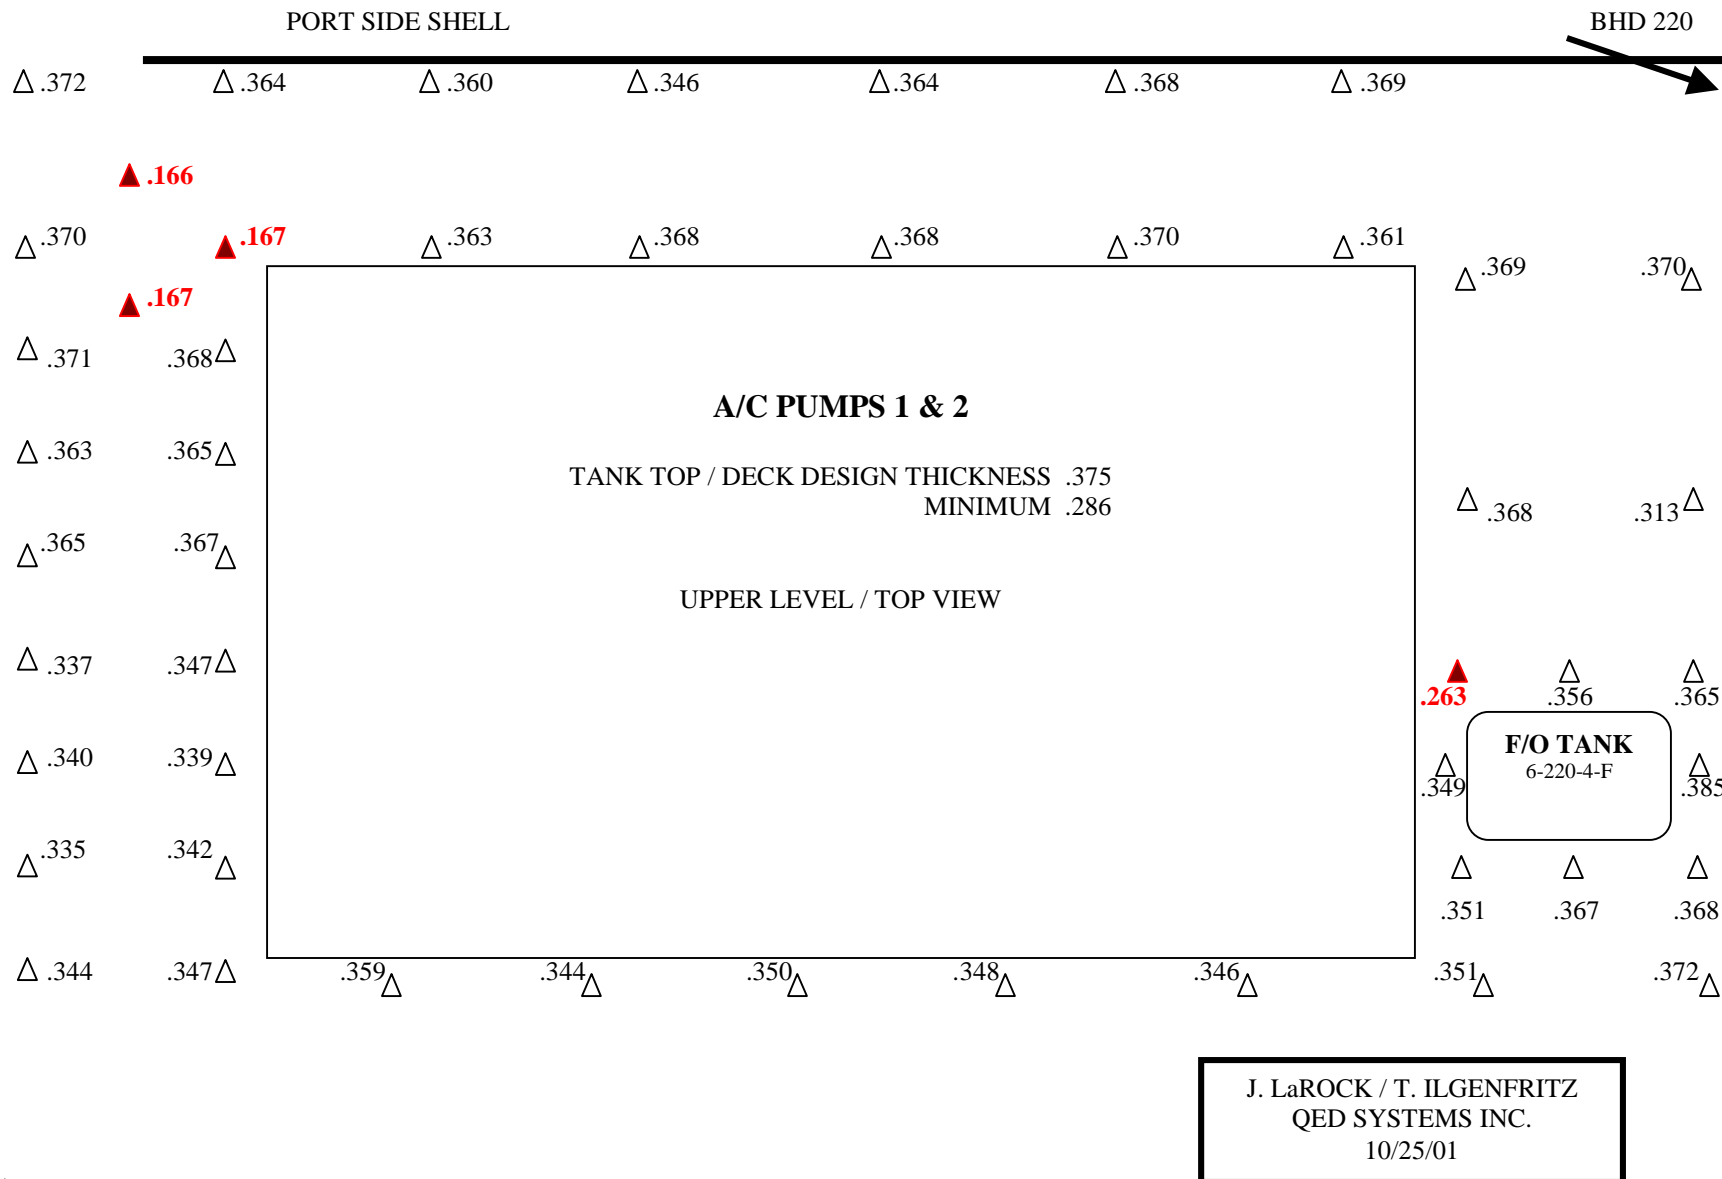
USS VICKSBURG (CG-69)
AUXILIARY MACHINERY ROOM 1 (5-220-0-E)
PORT SIDE / UPPER LEVEL

TANK TOP / DECK BETWEEN A/C PUMPS 1&2 AND PORT SIDE SHELL
APPROXIMATELY 2 SF OF AREA REVEALED LOW U/T READINGS
NOTE HEAVY BLISTERING OF PAINT

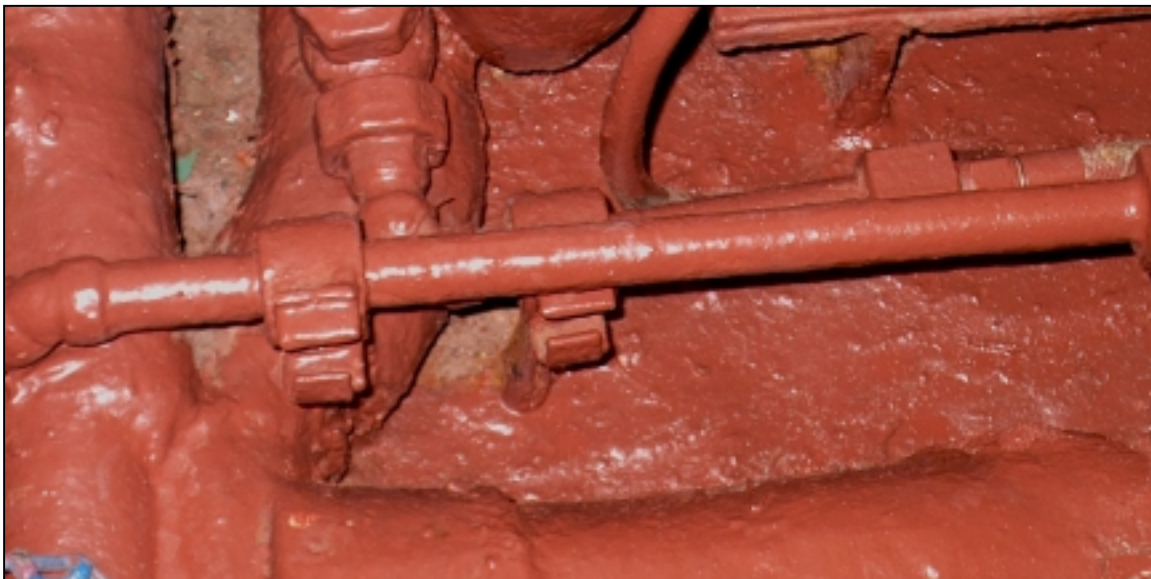
DECK INBOARD OF (60 / 400 HZ CONVERTER 1STCA)
CONCENTRATION OF PIPING PREVENTS SHIP'S FORCE FROM PERFORMING
PROPER MAINTENANCE

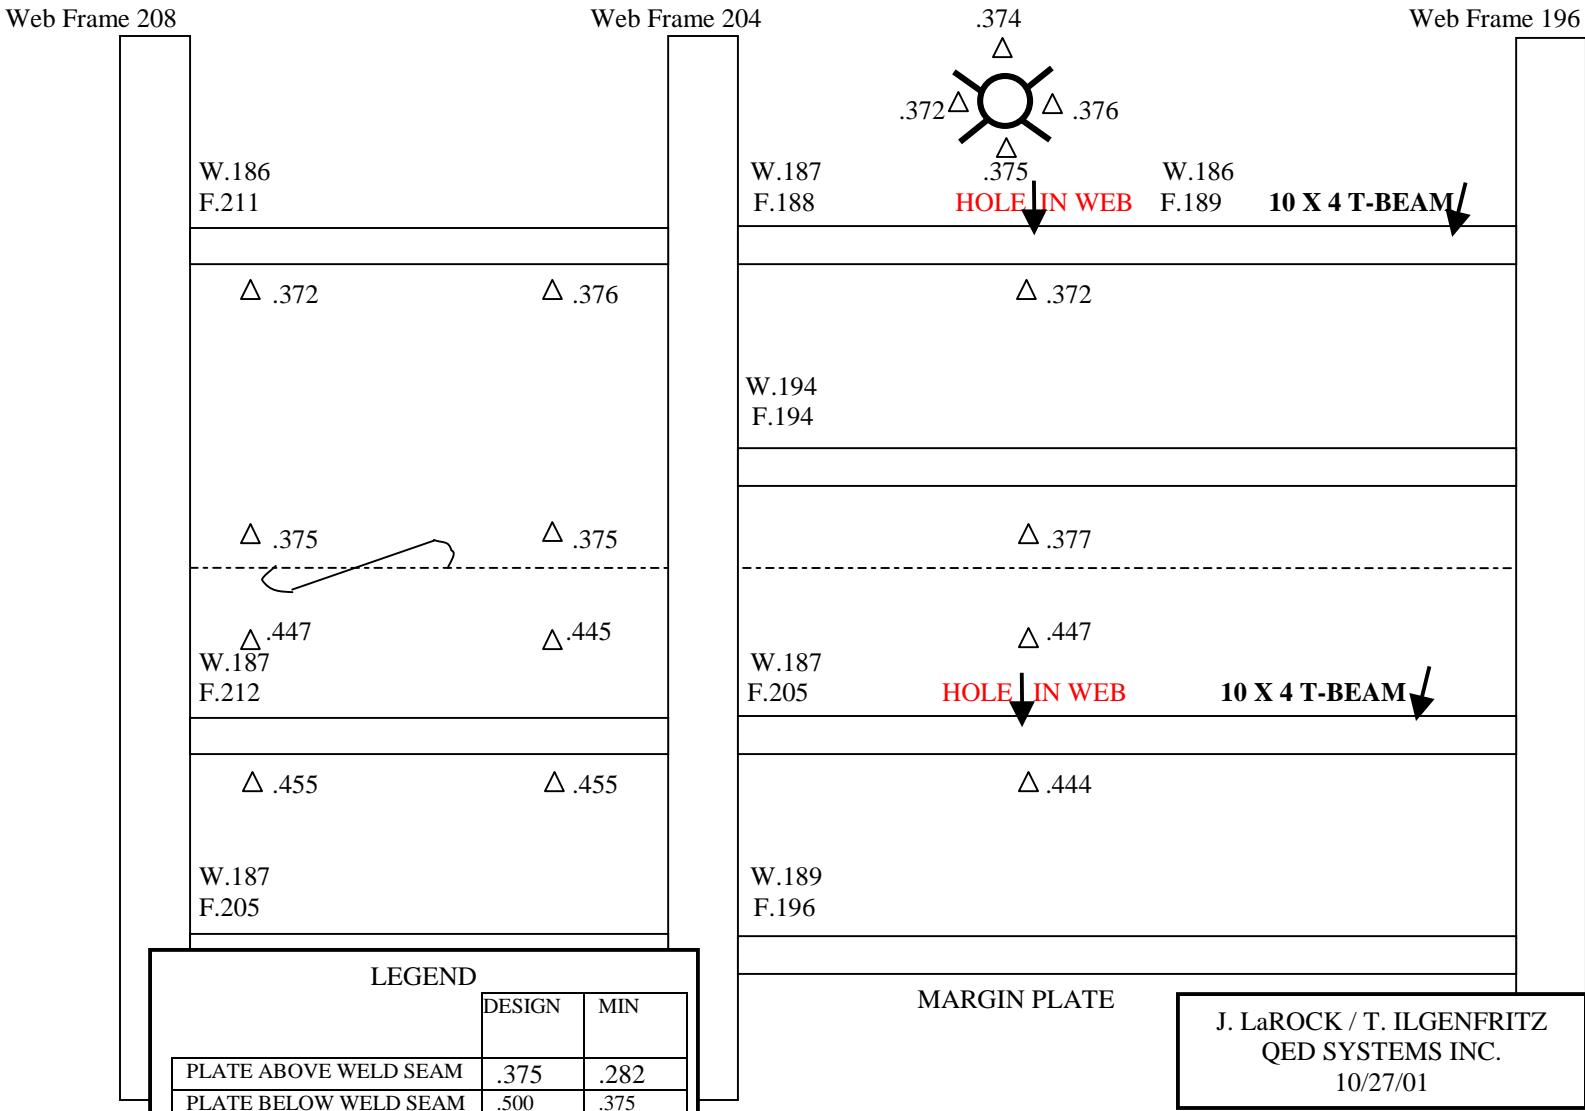
USS VICKSBURG (CG-69)
MAIN ENGINE ROOM 1 (5-174-0-E)
PORT SIDE

HOLE IN 2ND STRINGER FROM MARGIN PLATE
REFER TO DRAWING FOR U/T READINGS OF AREA.

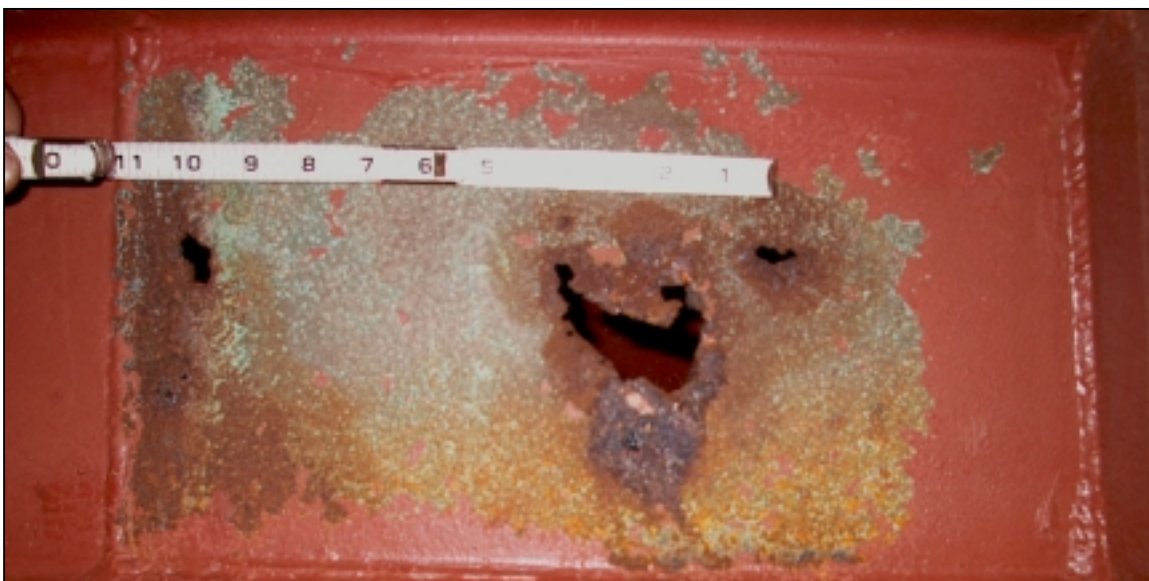
3rd STRINGER UP FROM MARGIN PLATE APPROXIMATELY 1 FT FWD OF
BHD (220), SEE DRAWING FOR U/T READINGS OF SURROUNDING AREA

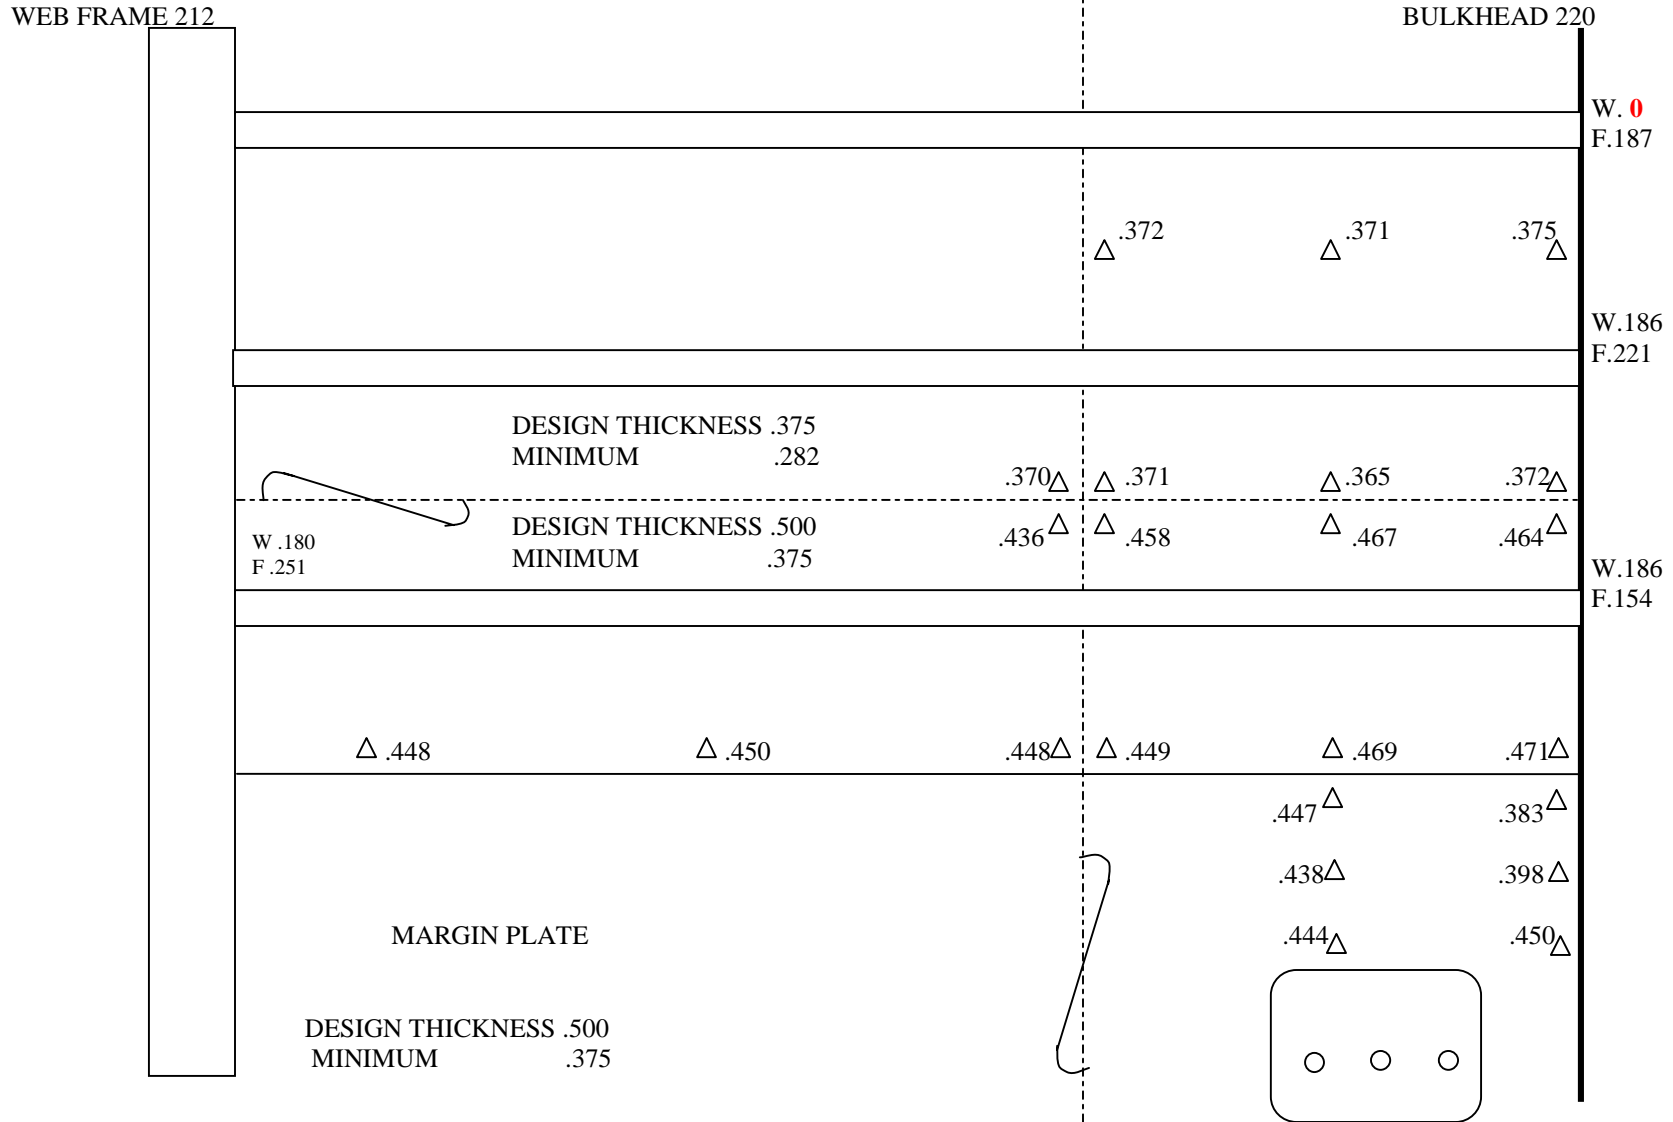
USS VICKSBURG (CG-69)
MAIN ENGINE ROOM 1 (5-174-0-E)
STBD SIDE

TOP OF FEED WATER TANK (5-216-1-W) PRESERVATION OF THIS AREA IS HIGHLY RECOMMENDED.

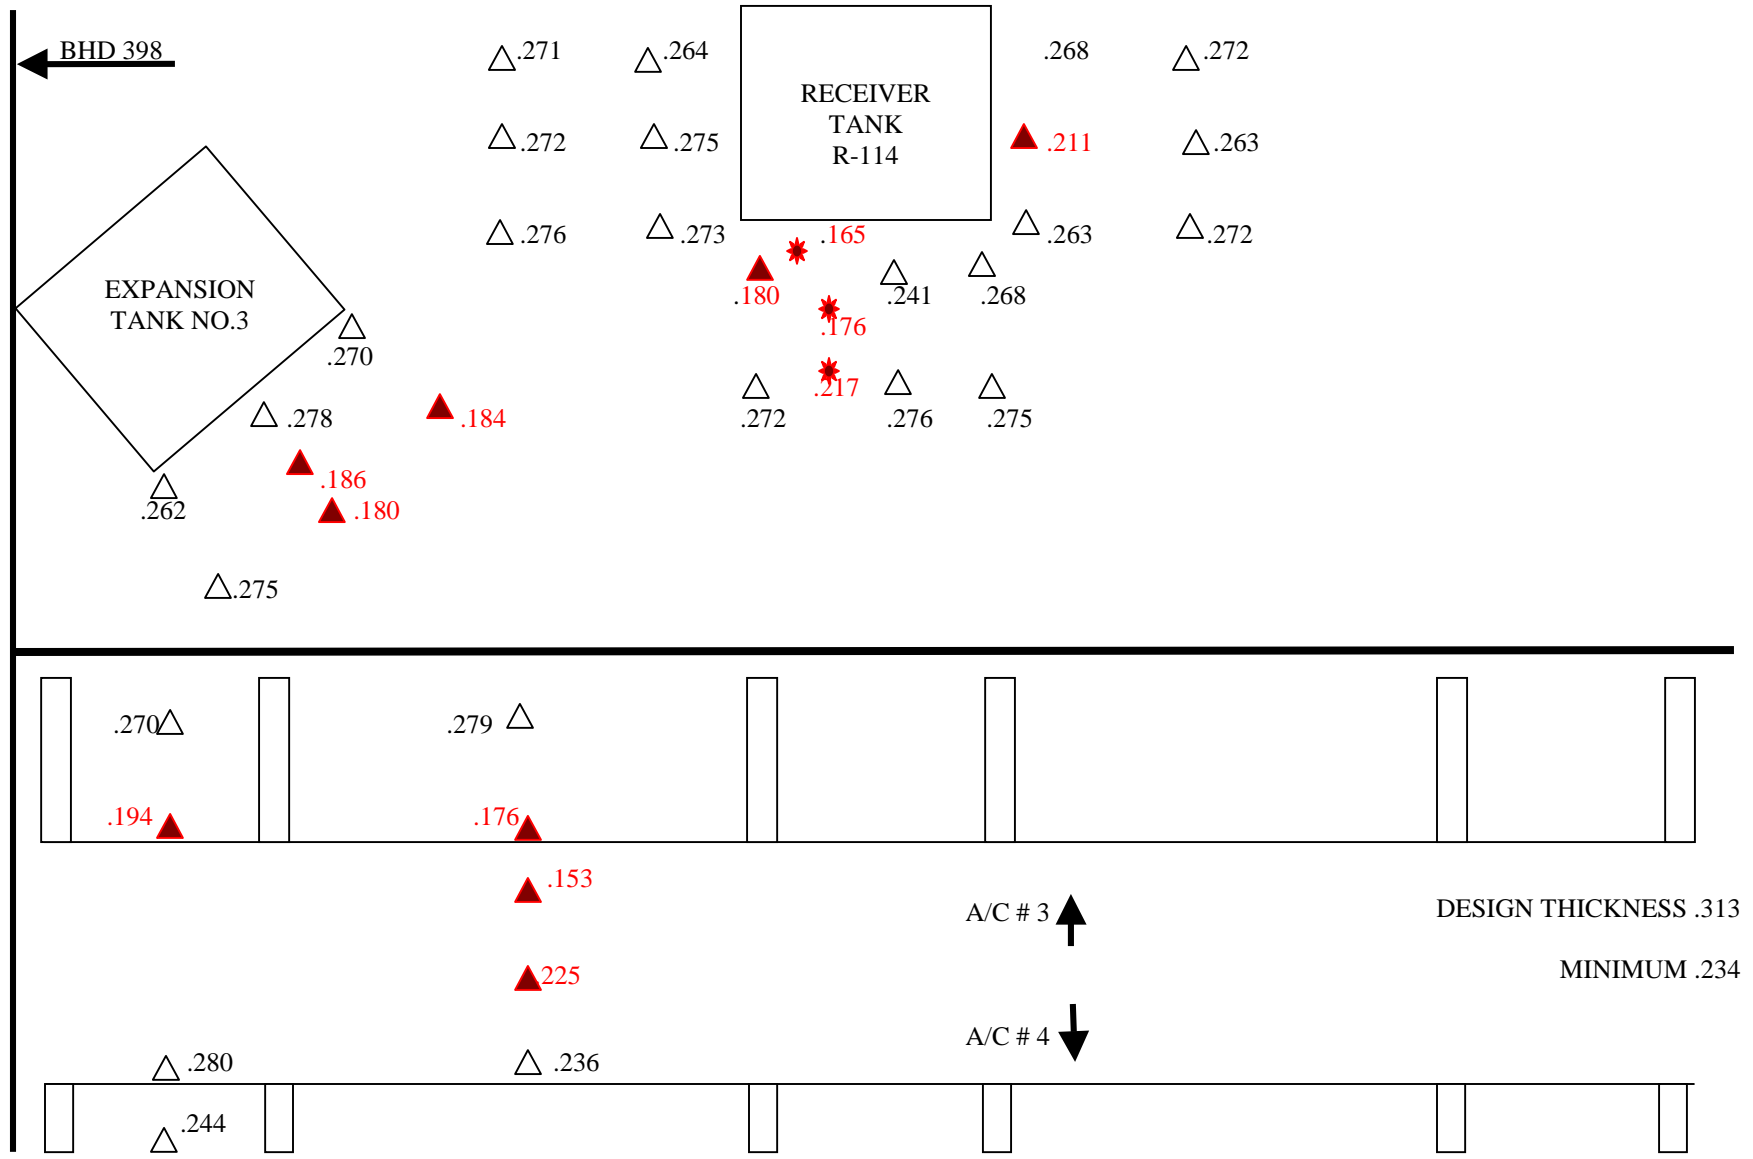
USS VICKSBURG (CG-69)
AC/JP5 PUMP ROOM (3-398-0-E)

TANK TOP / DECK BETWEEN BHD 398 AND A/C PLANT NO. 4
